Non Destructive Testing of Drystone Walls

Warren, Laura

Awarding institution:
University of Bath

May 2018

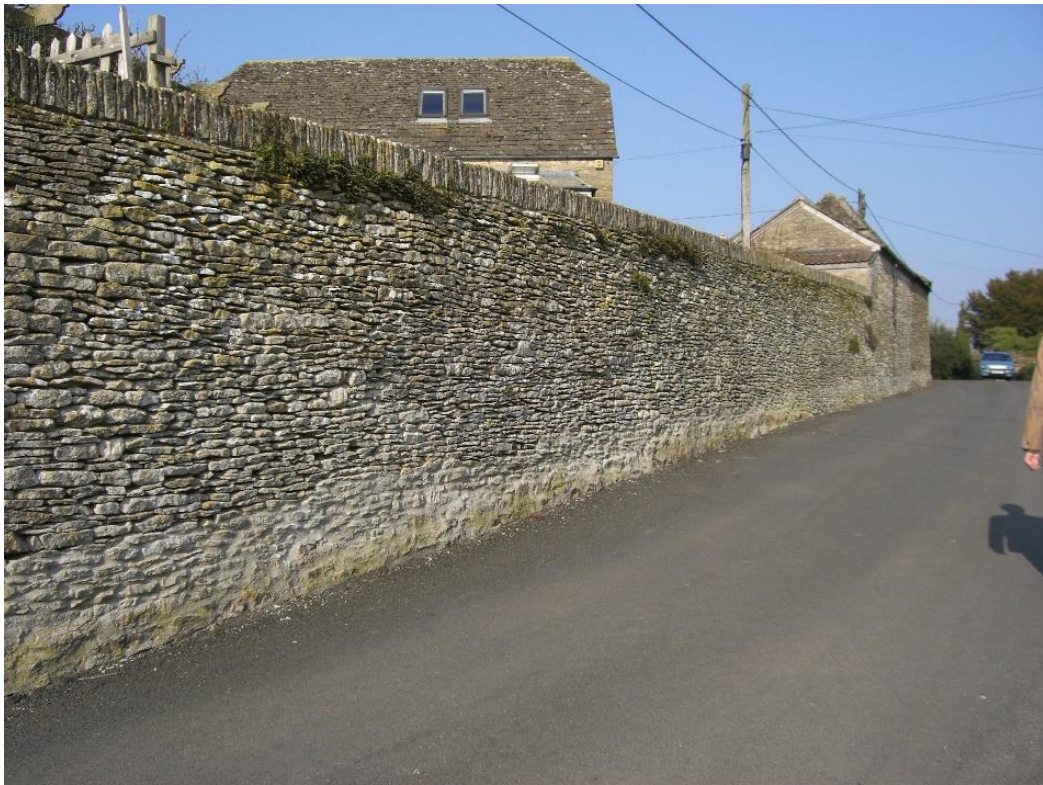
Figure 3.3: Garden Wall, Sherston. This wall is in a similar location to that in Figure 3.2, again abnormally straight with little batter. The bottom 10 courses (approximately) of this wall have been mortared, presumably to stop degradation from de-icing salts.

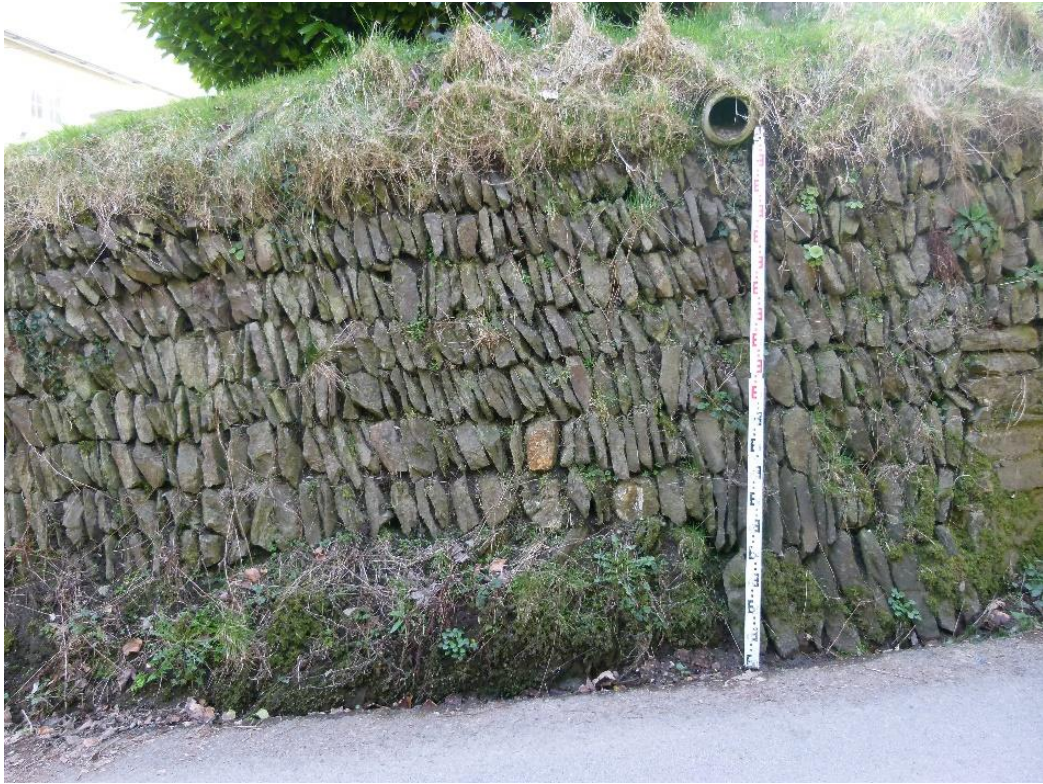
Figure 3.4: Vertical Construction, Brompton Regis. This is a wall typical to this location. Construction is typically only one stone deep with the longer axis of the stone into the wall. Some stones within the wall are relatively loose and can be moved by hand.

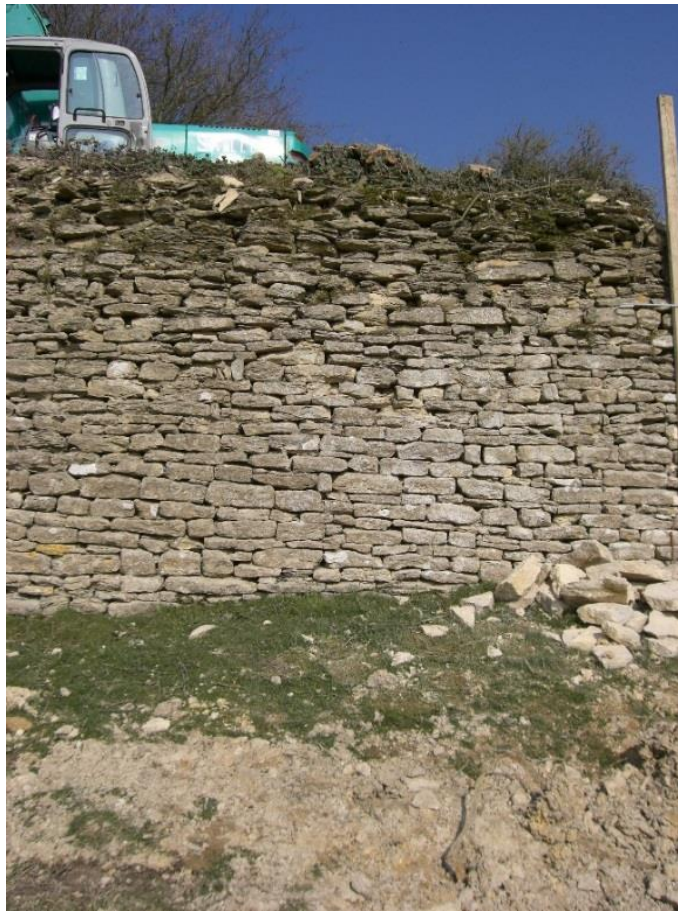
Figure 3.5: Wall Section, Northleach. This section is immediately adjacent to a section of wall that collapsed. Stones in this area show a high amount of degradation. However, despite the adjacent collapse this section showed no signs of deformation.

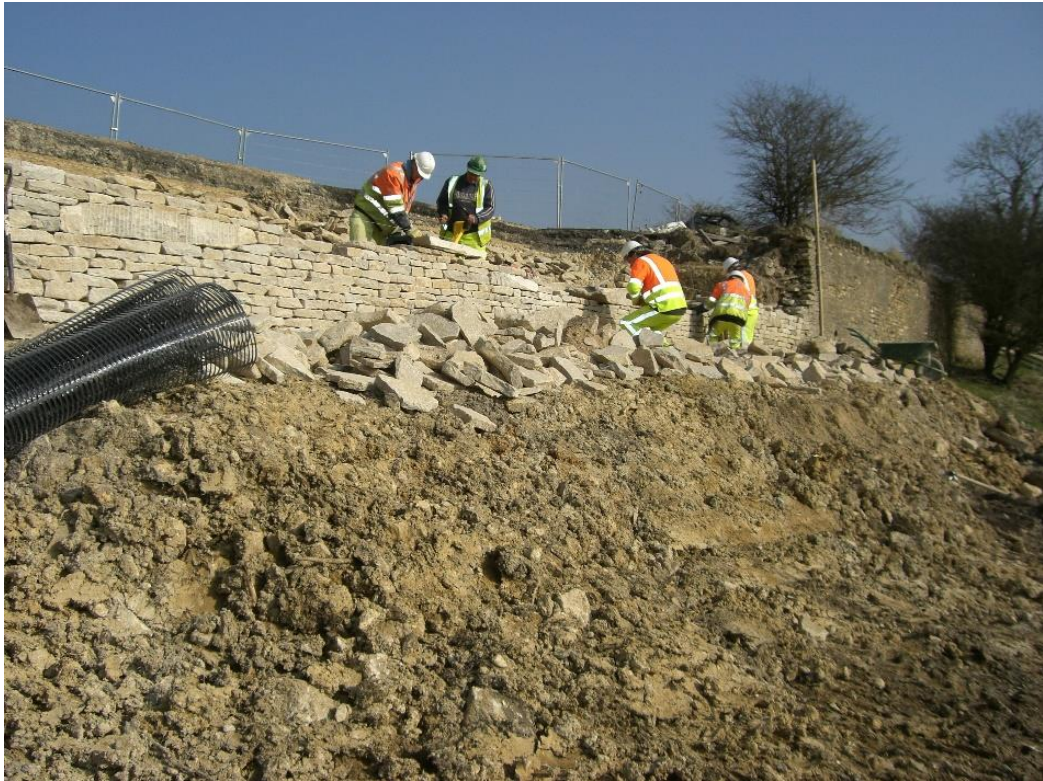
Figure 3.6: New wall under construction. This section of wall at Northleach collapsed and was under reconstruction, unusually using drystone. The section is noticeably wider than the original sections that can be seen either side of the repair, and has soil reinforcement in the retained fill.

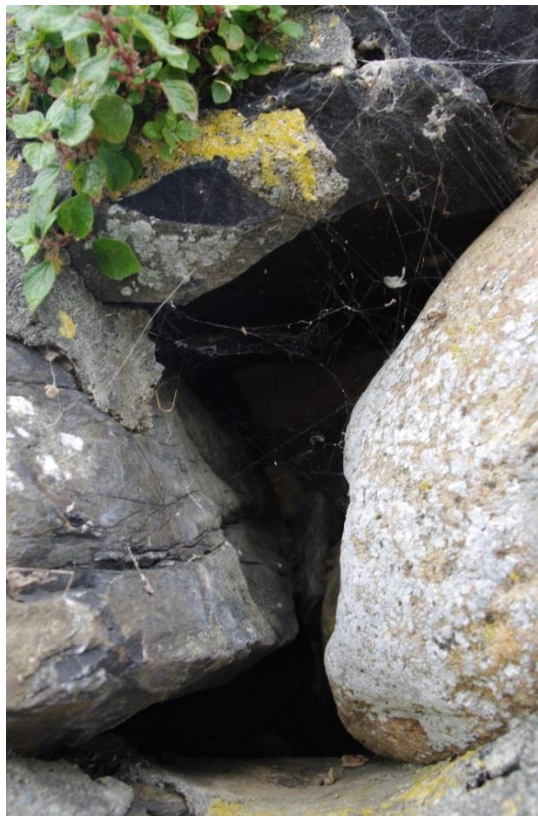
Figure 3.13: Mortared wall face, Mousehole, Cornwall. This wall has been pointed at its face. In places this has been broken away, and stones have moved (a). The drystone construction can be seen behind the face (b).

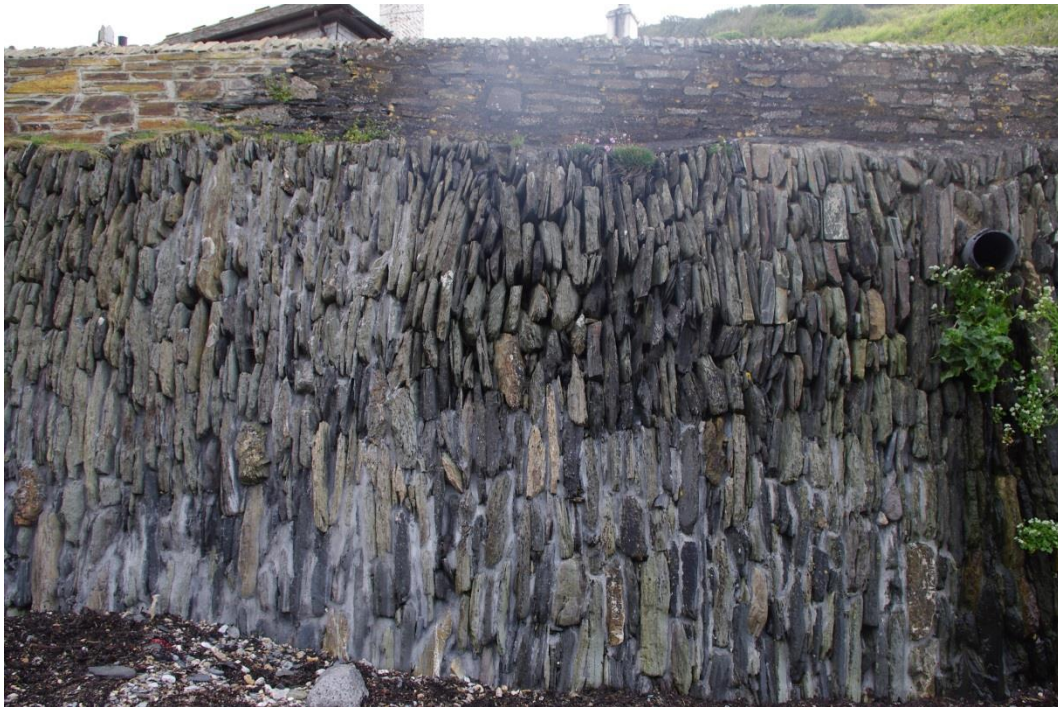
(a) Intact wall

Figure 3.14: Mortared wall, Port Gavern, Cornwall. Much of this wall section is mortared. In February 2014 large storms hit the Cornish coast and this section of wall collapsed (b). The area of collapse seems to coincide with the visually different area to the centre of the original image. This wall forms a retaining wall to the back of a small bay directly facing the sea, forming the main protection to the road and houses beyond. It is mostly above the high water line.

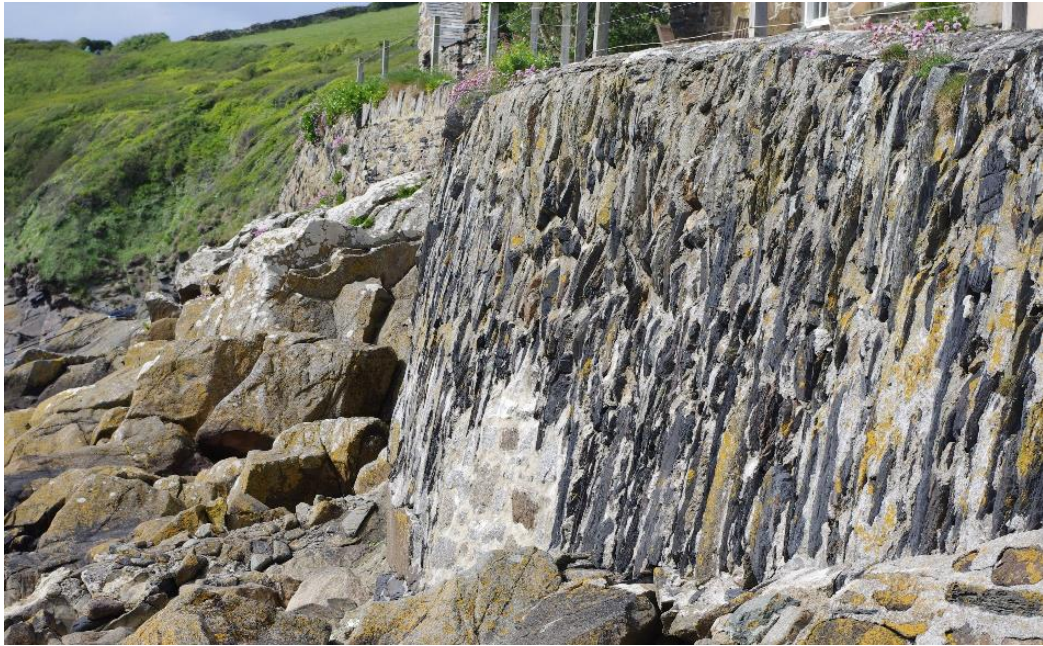
Figure 3.15: Mortared wall, Port Quinn, Cornwall. This wall is fully mortared, as were all the walls in this bay. These walls face directly to the sea as at Port Gavern, and form the main protection to a number of properties. Mostly above the high water line.

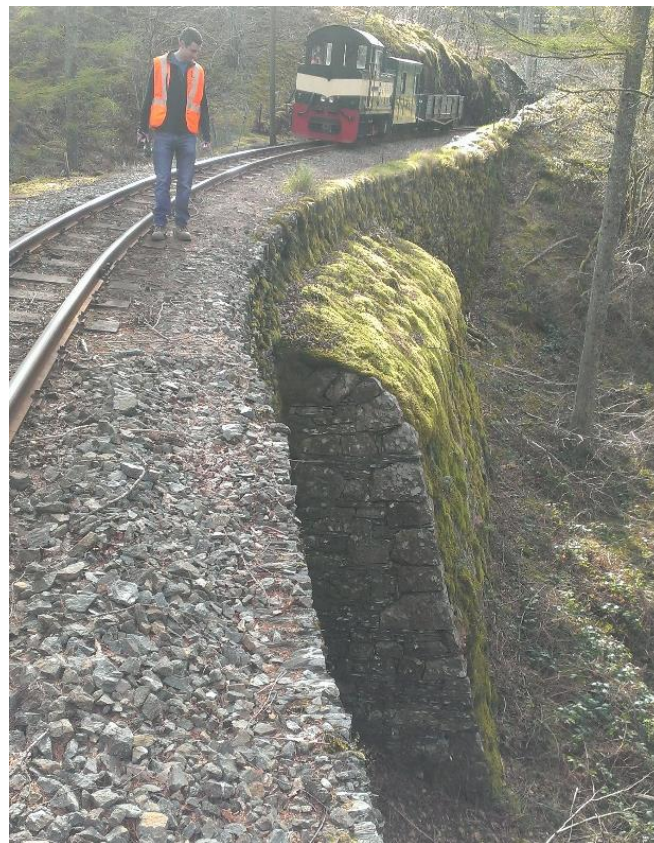
Figure 3.16: Buttress example, Ffestiniog Railway. This shows a typical buttress example built up against the face of the embankment with either a domed or flat top. At this section, the embankment is two sided and cuts through a wooded area. It has been known for the area behind the embankment (LHS image) to flood during wet periods putting additional forces on the structure.

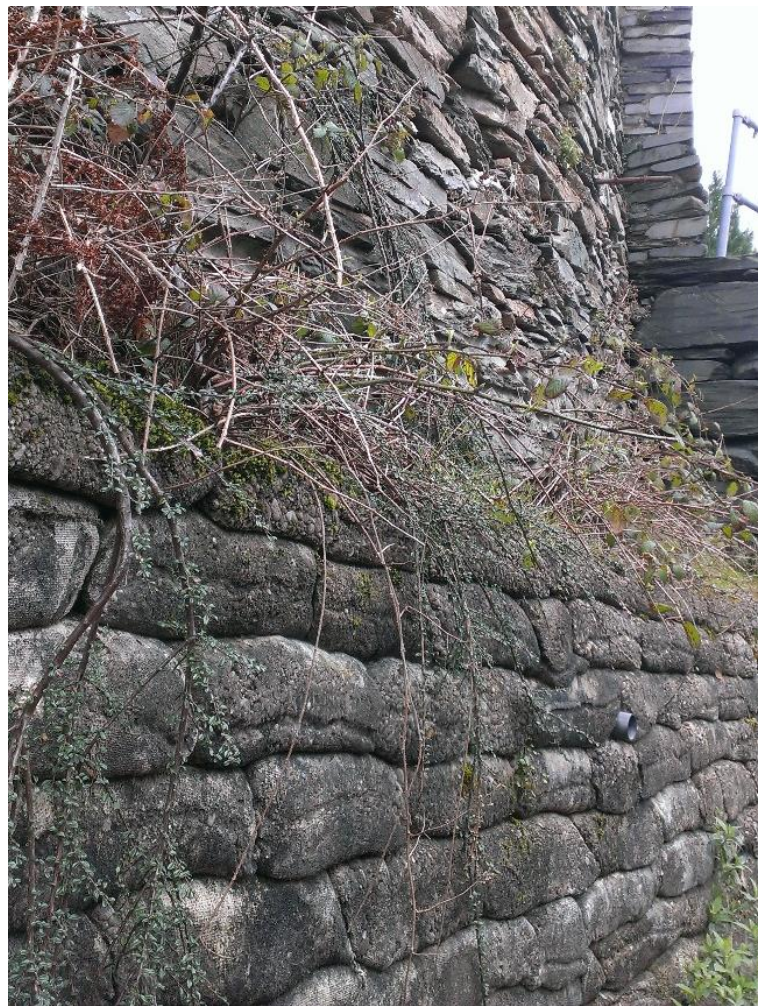
Figure 3.17: Foundation protection, Ffestiniog Railway. In areas particularly toward the top of the railway in the mountains, the embankment walls are constructed directly onto the bedrock. Here the issue is that the bedrock is not of such good quality as the wall above it and is degrading, endangering the wall. To alleviate this and to protect the bedrock below, sandbags of cement have been stacked against the bedrock face and allowed to cure. This contains the degrading bedrock as well as preventing further erosion.

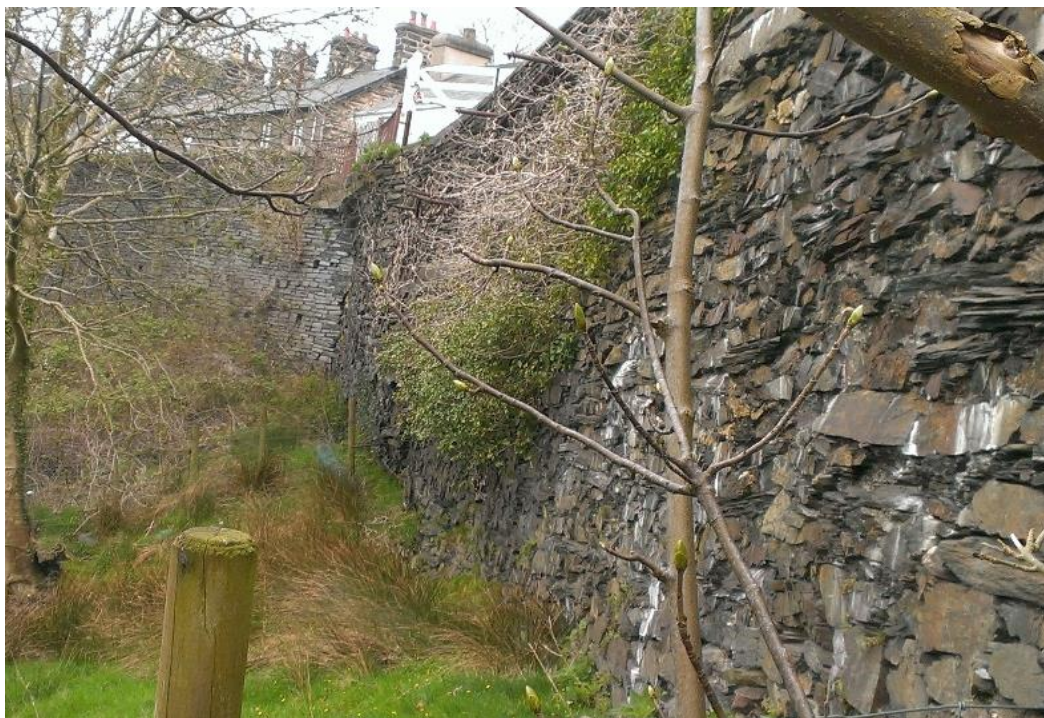
Figure 3.20: Unstable wall, Ffestiniog Railway. This section of wall is adjacent to where the railway crosses a road. It appears particularly unstable and is of concern to the railway. The issue here is access as it is one of the few walls facing onto private land. Due to the access issue, unfortunately this wall could not be investigated fully as part of this research. Some historical repair has been carried out as seen below.

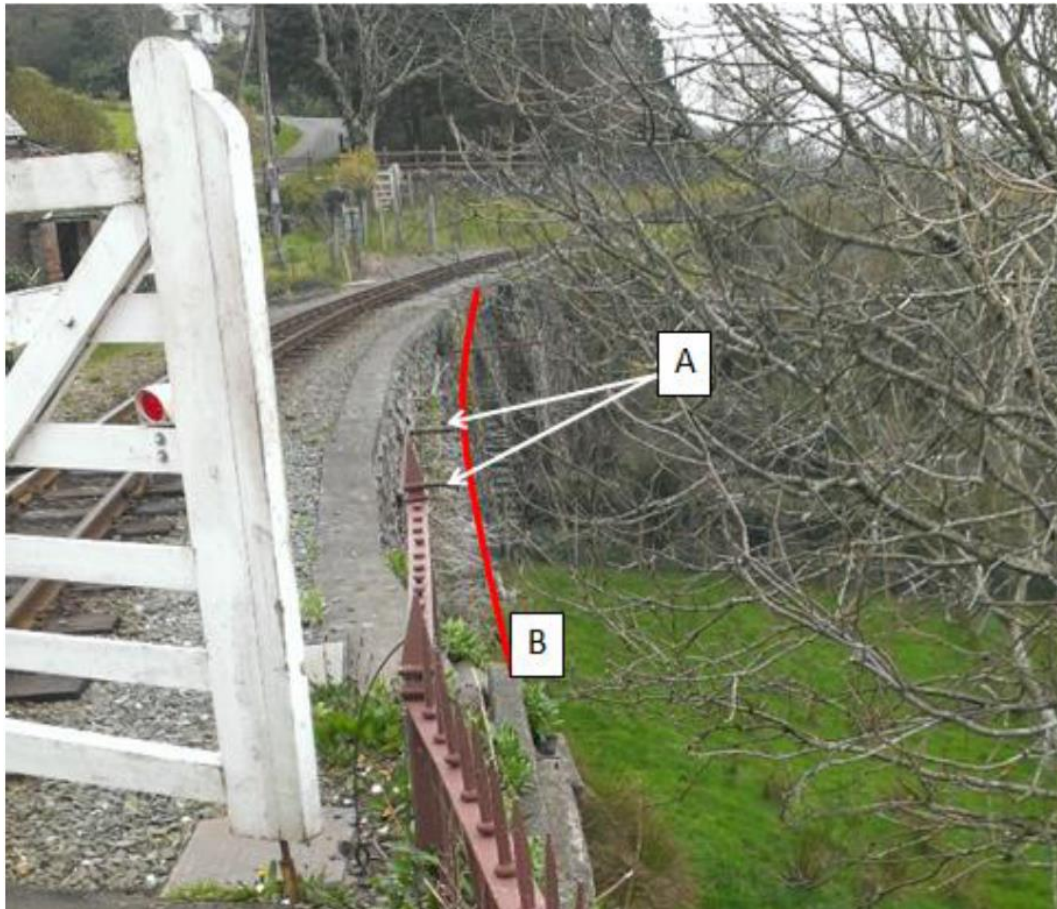
Figure 3.21: Unstable wall realign, Ffestiniog Railway. This is the wall in Figure 3.20 from above, taken from the road where the railway crosses. Here you can see the old tie bars (A) that were inserted to keep the wall stable prior to previous works. Approximate line of original wall shown (B).

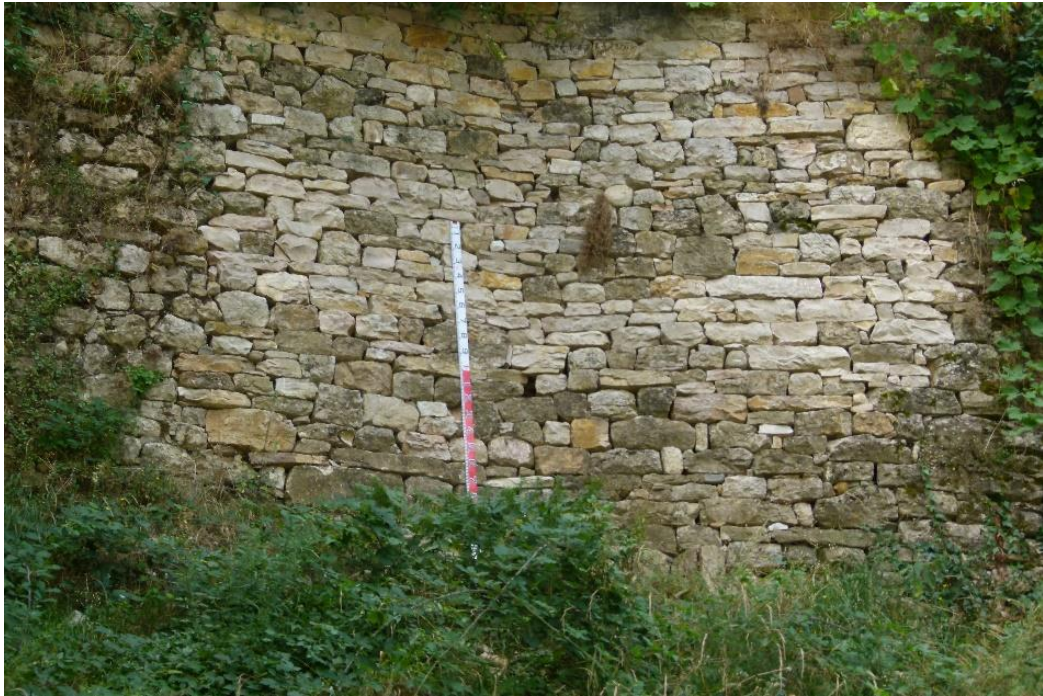
Figure 3.23: River wall St Enimie, France. This is a modern wall around 4m high constructed from limestone. Situated directly next to the river it is subjected to annual flooding, which can be of significant height. It shows no sign of distress.

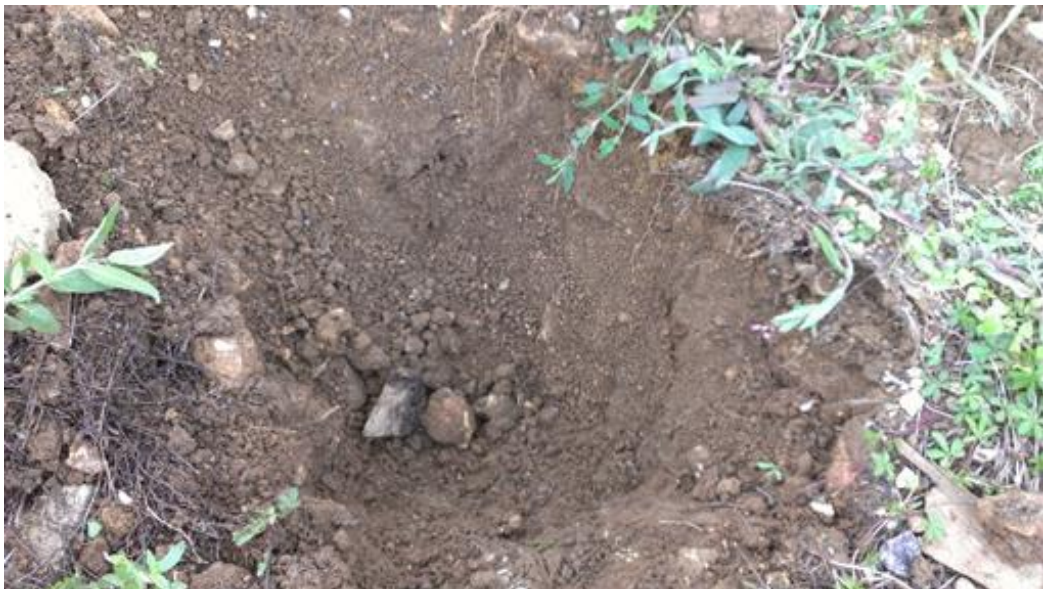
Figure 6.4: Fill Excavated in area of interest to right of wall. Though not immediately obvious in image, this area appeared darker than that around it with a higher stone and moisture content.

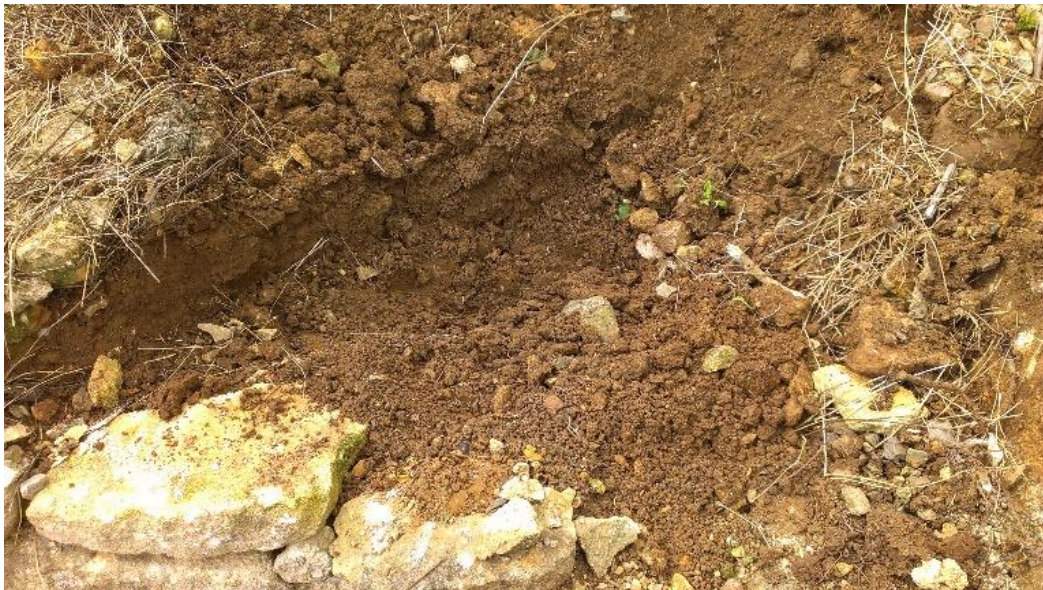
b) Backfill under stone when removed, showing loosely compacted top soil

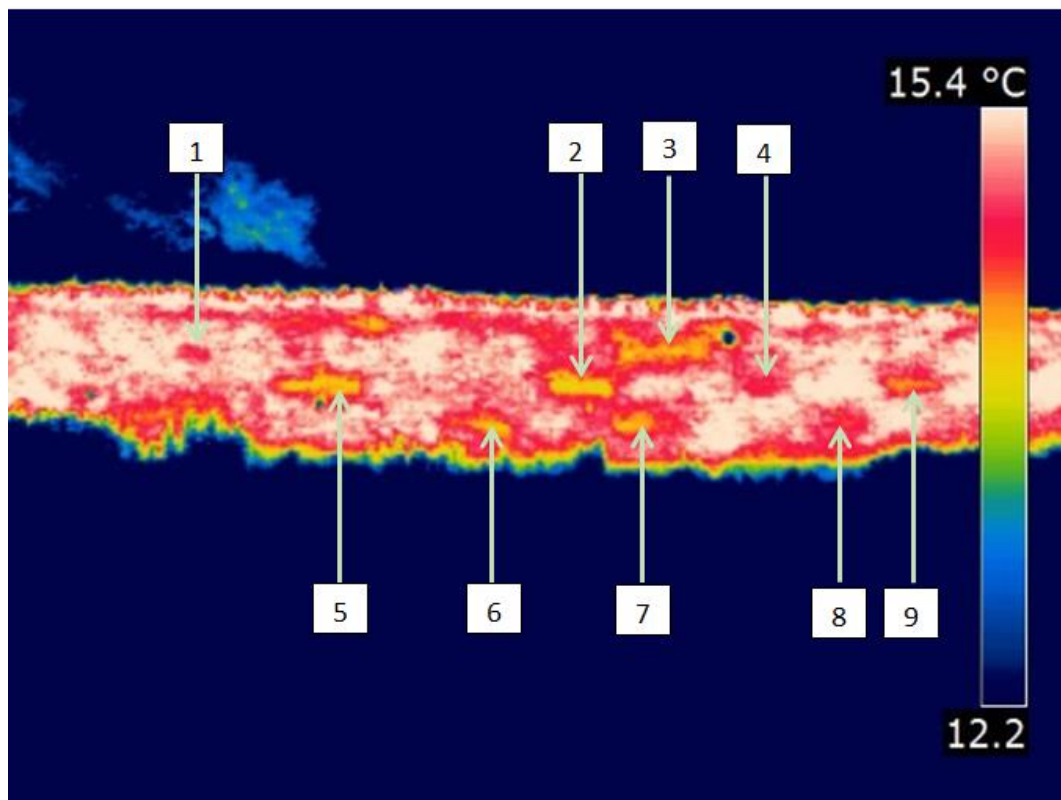
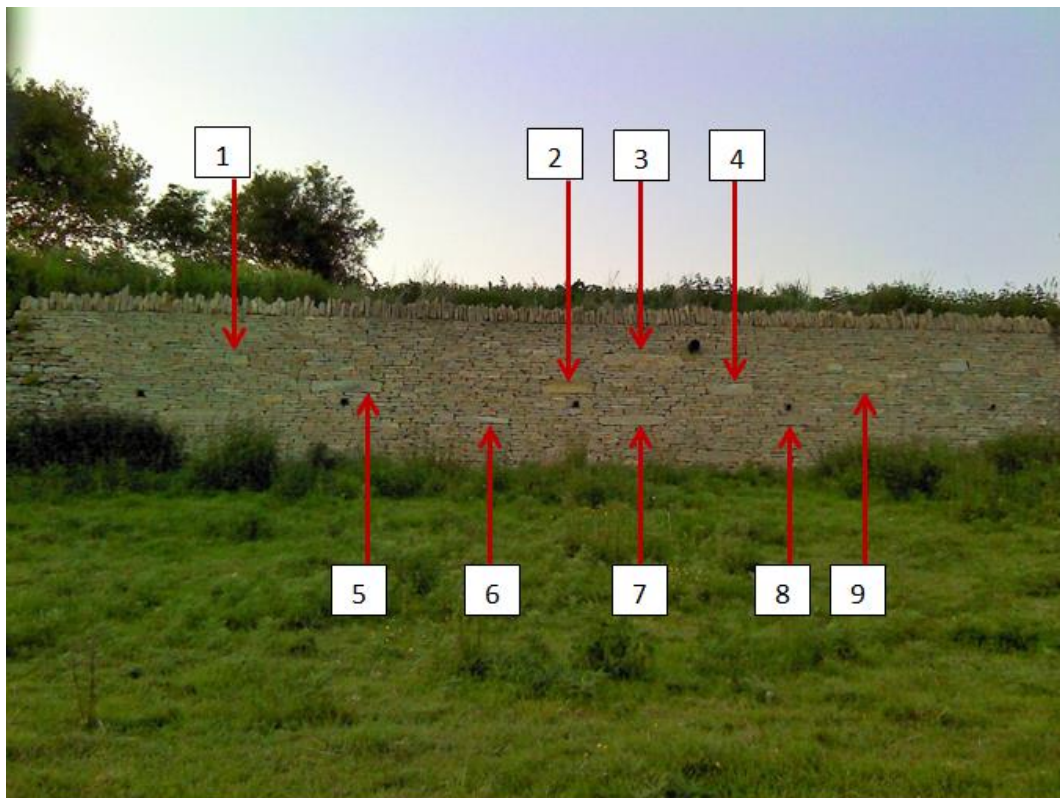
Figure 7.9: Northleach Wall Section 1 – Image taken 06/06/2013 at 20:00hrs when the wall was no longer exposed to direct sunlight. The through stones which are also visible (1-9) in the visual image can be seen to be cooler than the surrounding wall by approximately 1.5degC. This image forms part of the data set shown in Figure 7.10.

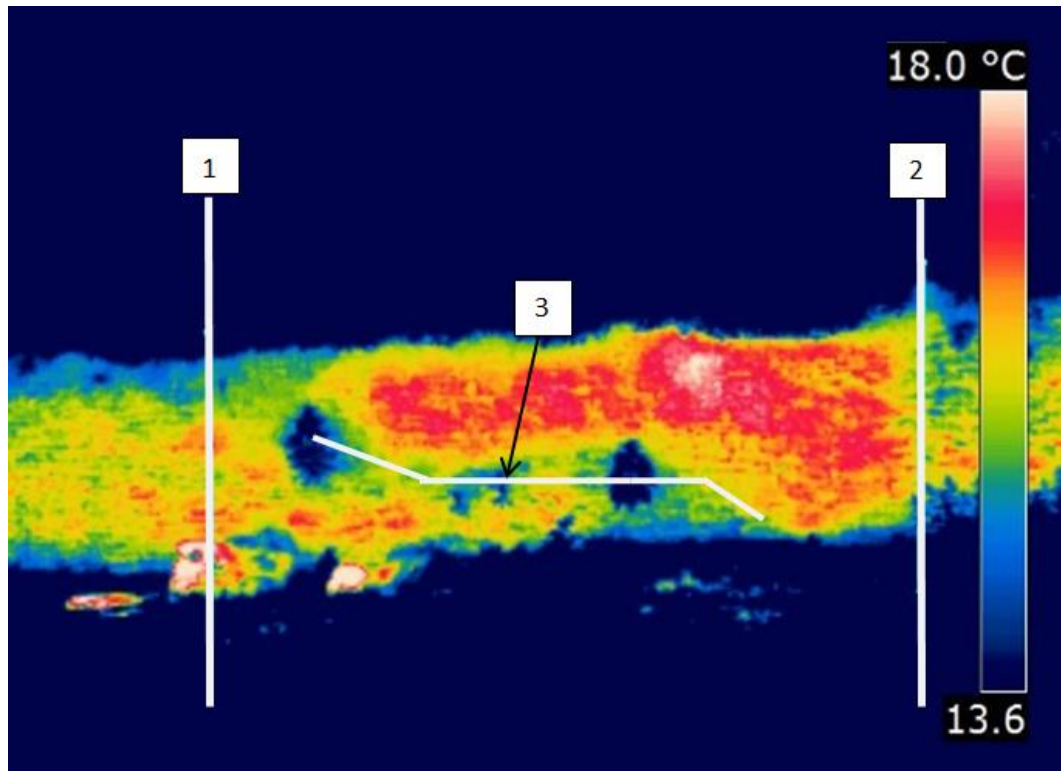
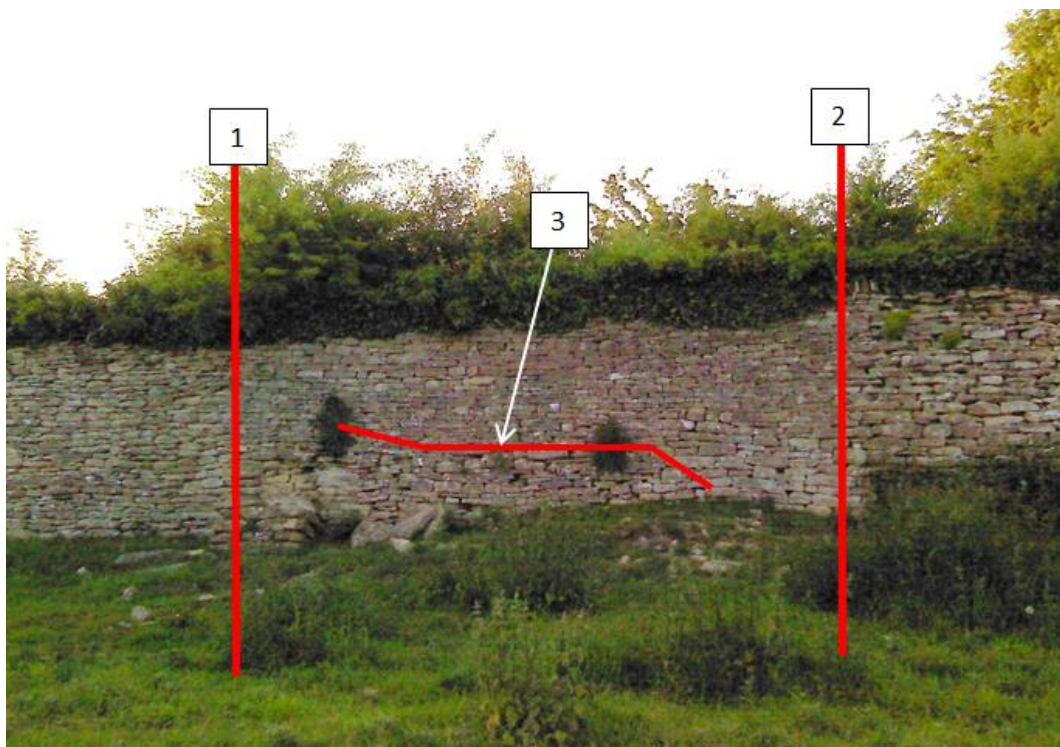
Figure 7.13: Northleach Wall Section 3. Image taken 06/06/2013 at 20:00. In the image it is possible to see temperature changes where the face construction changes (lines 1&2), as well as a cooler area between the two patches of vegetation (line 3), evidence of which is not evident at the wall surface.

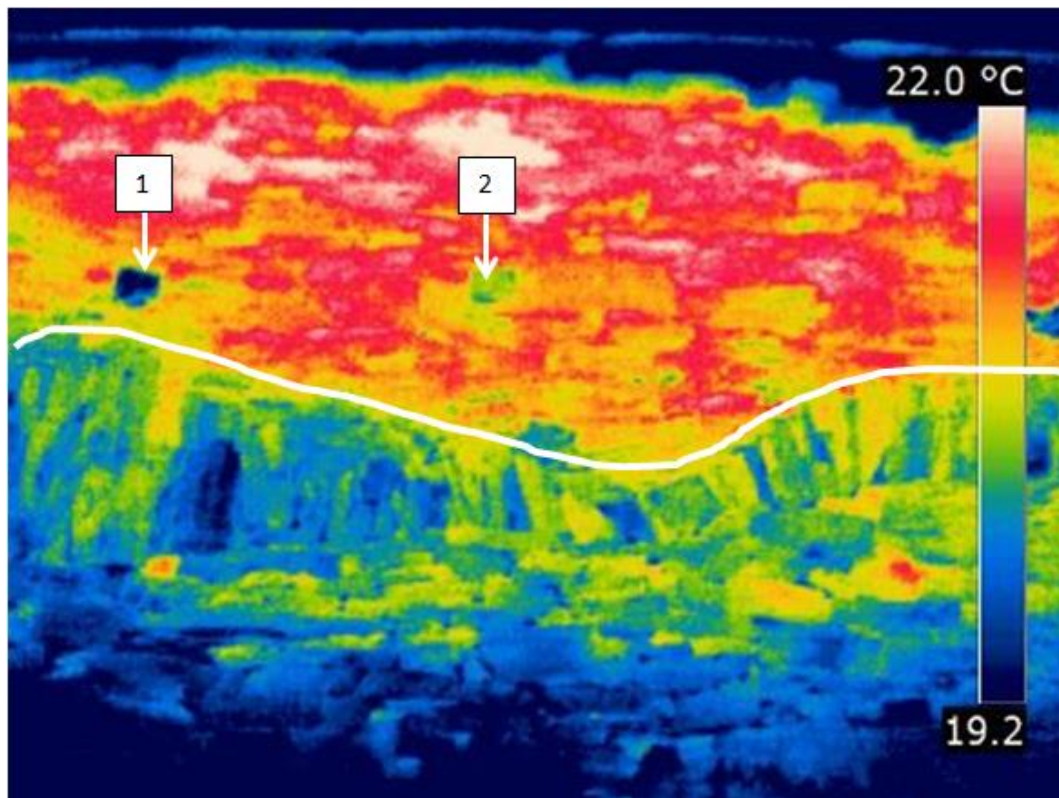
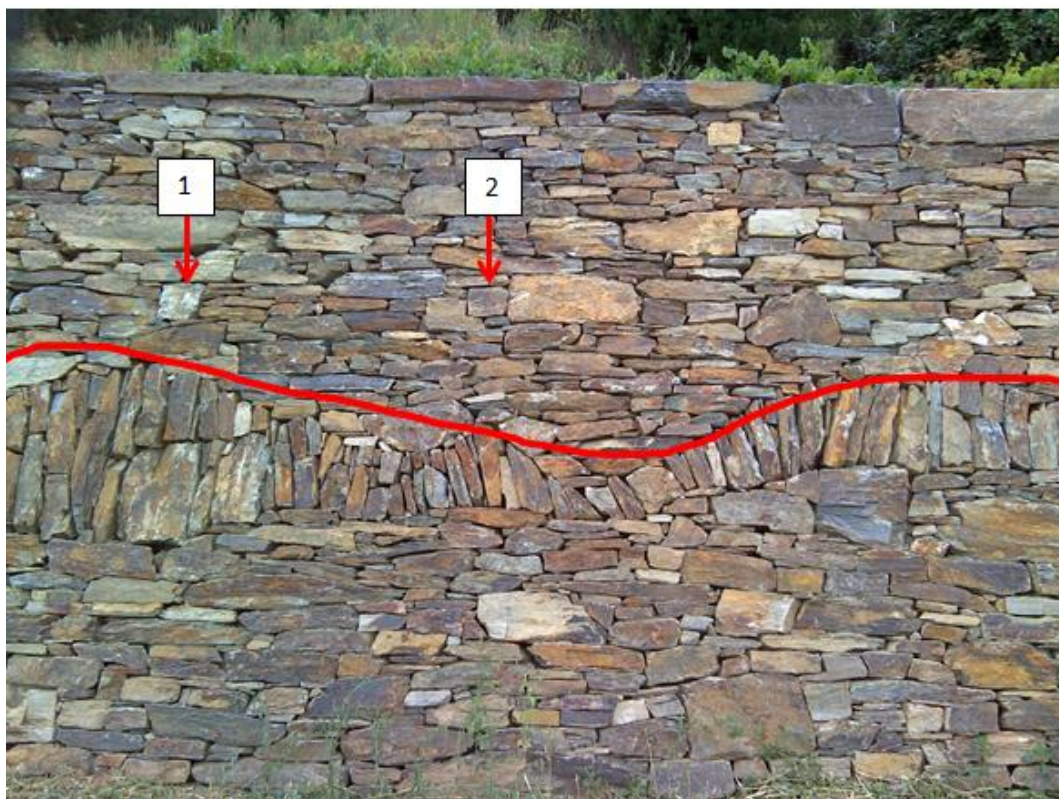
Figure 7.14: 3m High, North Facing Wall in L'Espinas on the D45, France. Situated on Private property Taken 10.55 07/09/2013. Showing potential through stones that are not obvious at the face (1&2), and the obvious temperature difference between the top and bottom of the wall face, indicating at differences in material behind wall.

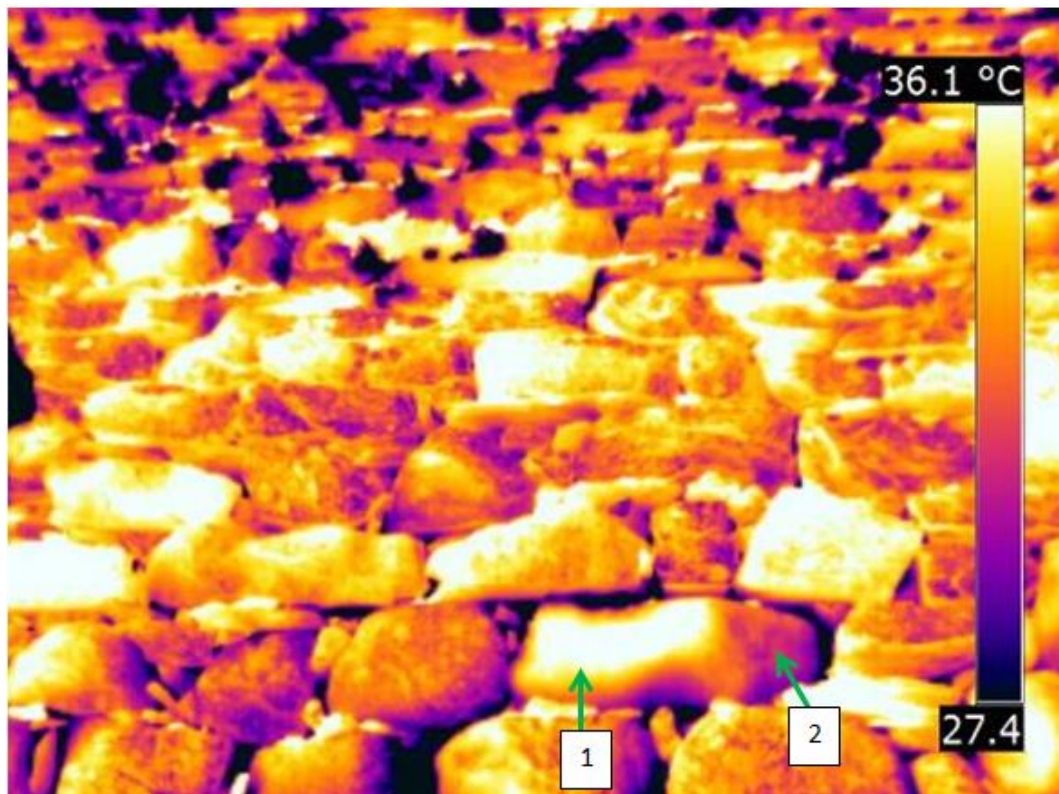
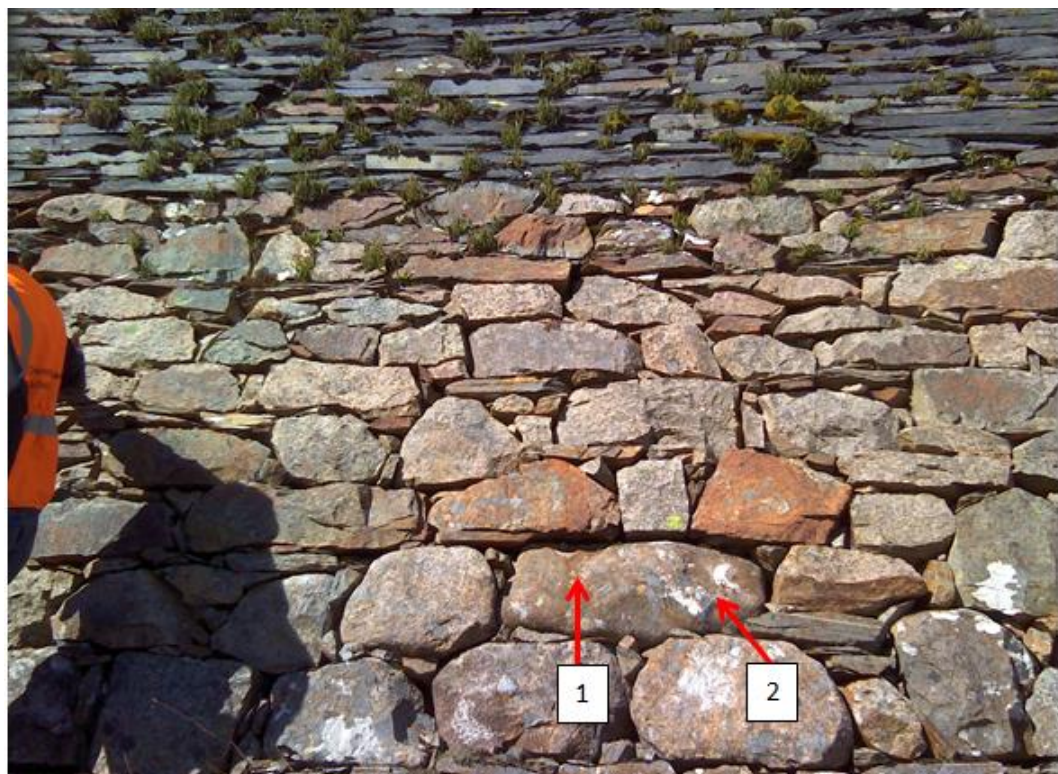
Figure 7.19: Between Tanybwllch and Dduallt, South-South East facing, supports railway. Image taken 14:00 01/04/2014. Showing the effects of stone face angle in the wall. From the shadow the direction of the sun can clearly be seen. The stone face facing the sun (1) is significantly warmer than that not (2). An effect seen on many of the stones in this image.

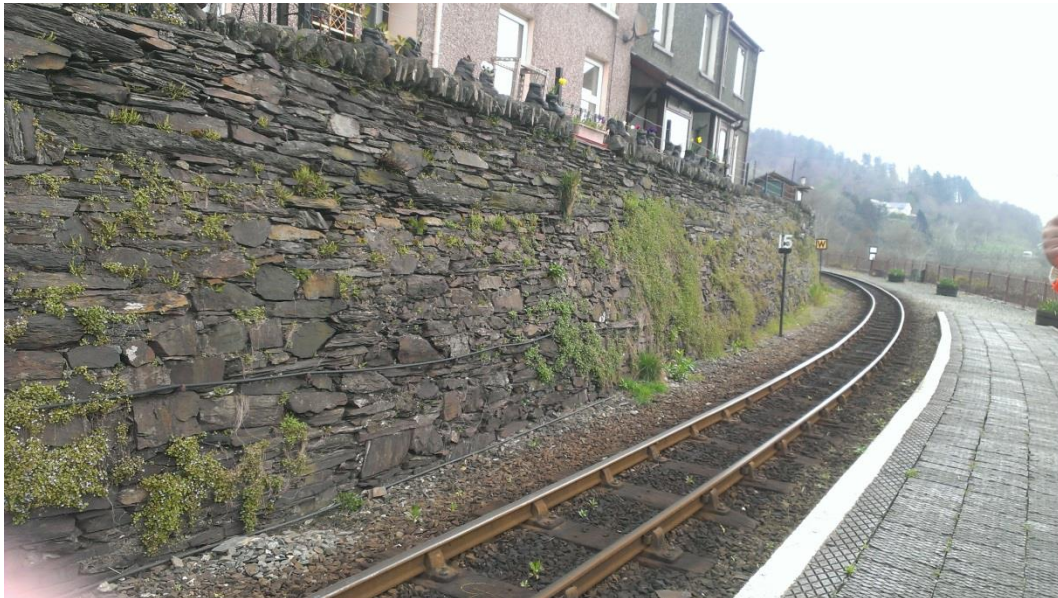
Retaining wall adjacent station platform with residential properties behind. This wall shows signs of having bulged but appears to be in good condition and relatively stable.

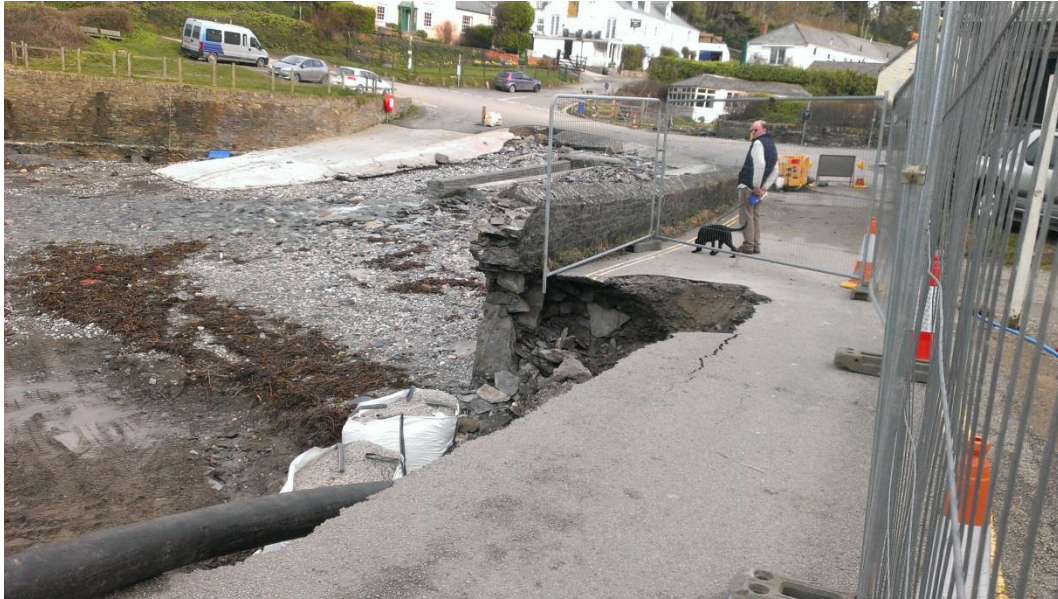
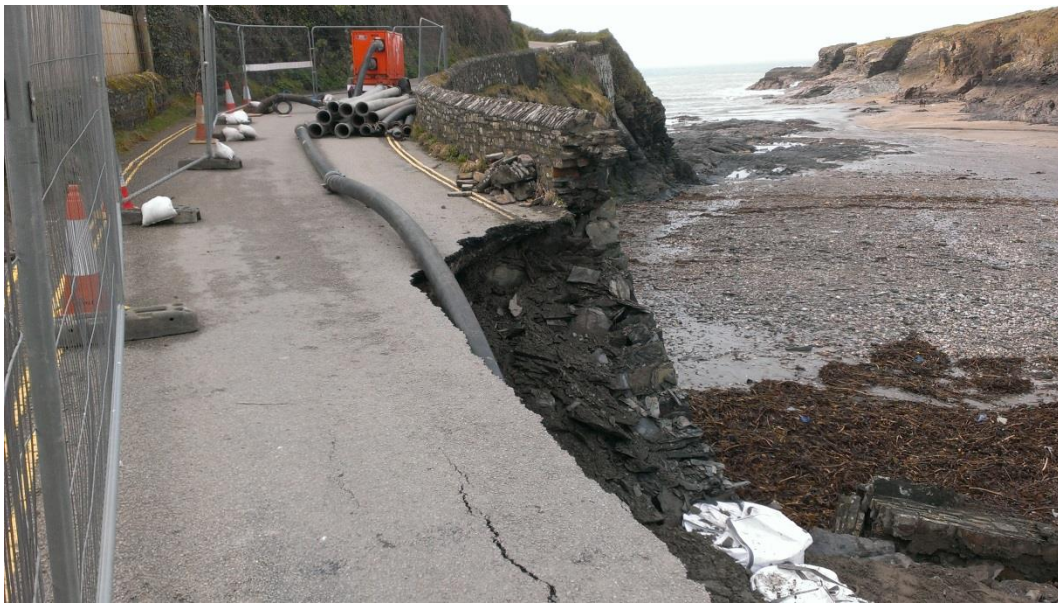
Damage to road above collapse

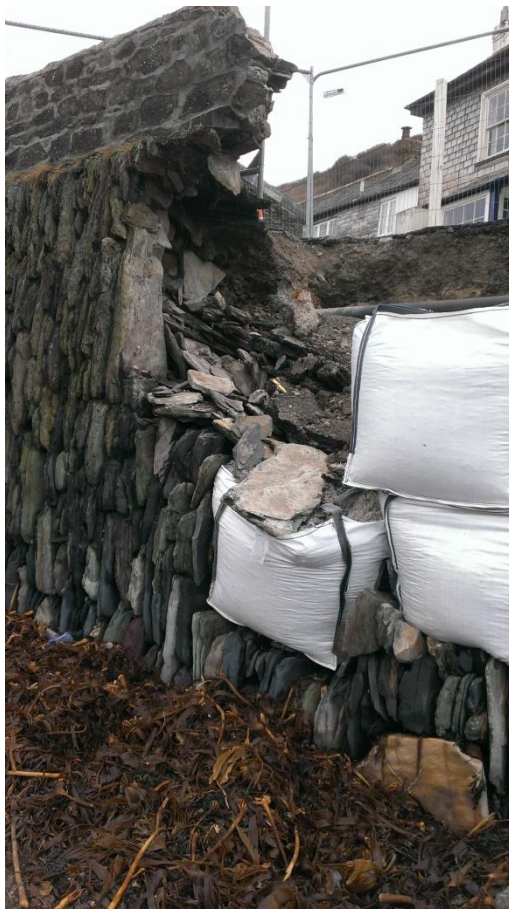
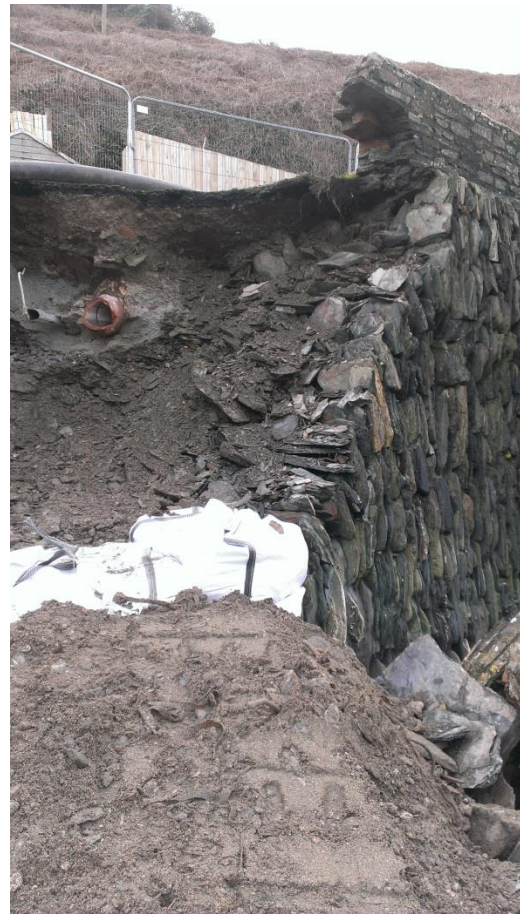
Ends of collapse showing wall construction and thickness, as well as signs of services effected

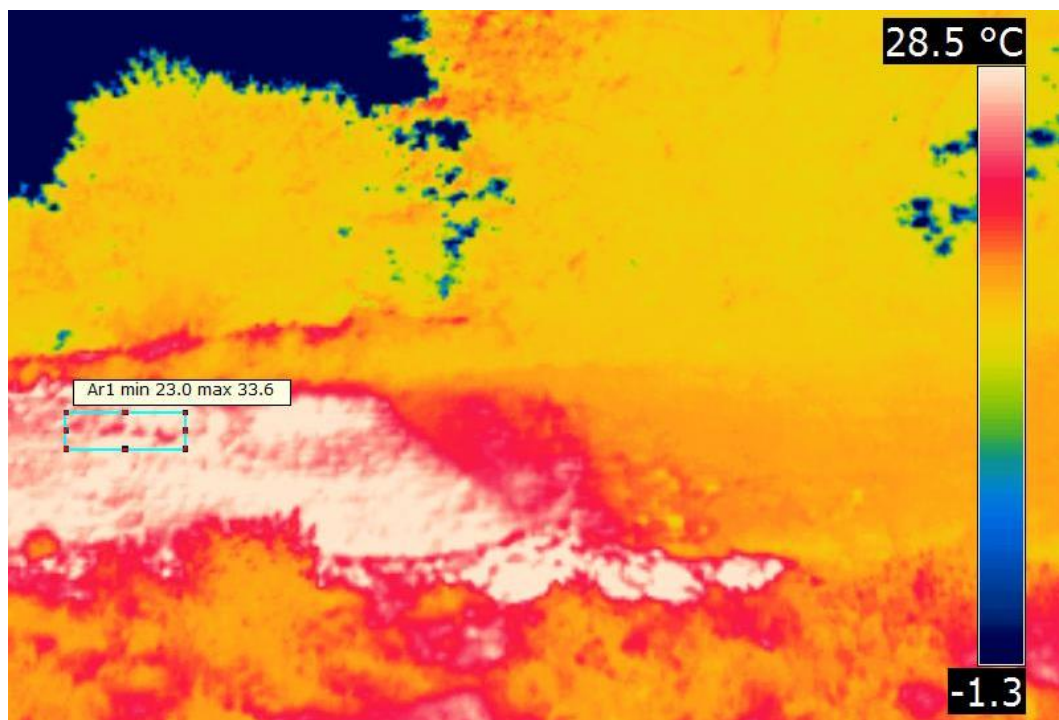
Image taken: 15:00 06/06/13; little information shown from thermal image, main temperature variation between mortared and non-mortared area. Mortared area also shaded by tree. Some variation shown where masonry missing/weathered (highlighted)

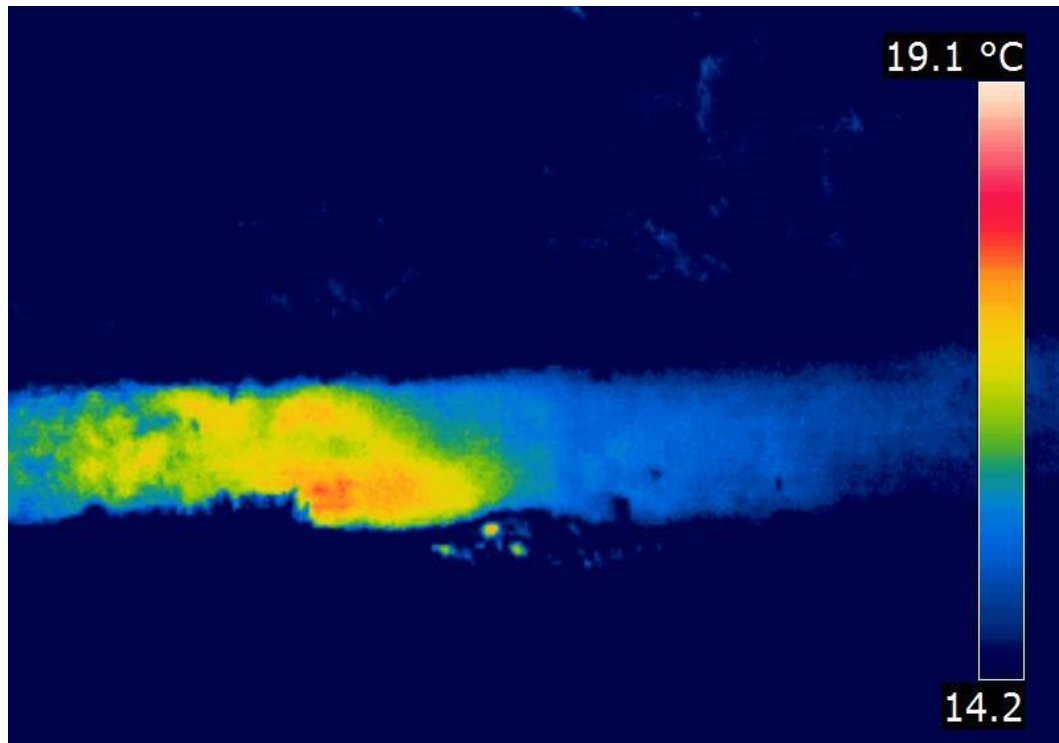
Image taken: 20:00 06/06/13; no information shown. Main temperature change between mortared and non-mortared area.
